## The Effect of Rail Head Corrosion on Emergency Brake Activation in Electric Multiple Unit (EMU) KCIC400AF-2208 on Track I-11G2 at KCIC Tegalluar Depot, Bandung Regency, Indonesia

Prandy Agus Estrada Depari<sup>1</sup>, Popik Montanasyah<sup>2</sup>, Femmy Sofie Schouten<sup>3</sup>

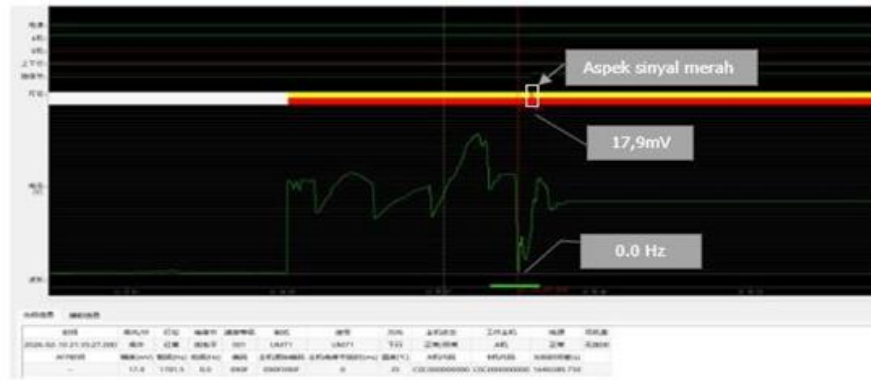
**Picture 1 Track Circuit Reader (TCR) Voltage Reading During the Emergency Brake Incident**

As illustrated in Picture 1, the track circuit signal voltage fluctuated significantly when the train entered Track I-11G2. At 21:35:27 WIB, the signal voltage dropped to 17.9 mV, which was considerably lower than the minimum operating value of 240 mV required for the ZPW-2000A track circuit. Simultaneously, the low-frequency signal decreased to 0.0 Hz, preventing the ATP system from receiving valid occupancy information. Consequently, the signal aspect changed to Red (H), and the ATP system activated the Emergency Brake according to the fail-safe principle.

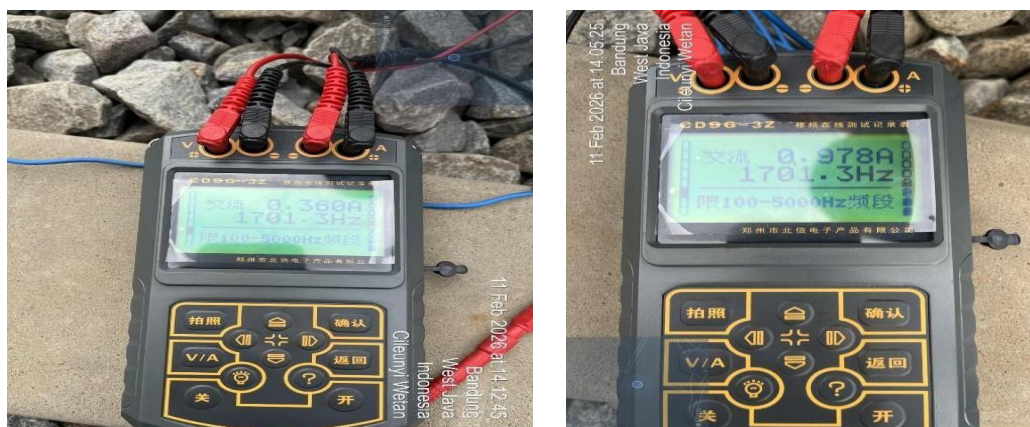
**Picture 2. Track Circuit Parameter Test Results Before and After Rail Corrosion Removal**

After confirming that the disturbance was not caused by signaling equipment failure, the analysis focused on the physical condition of the rail head as the primary cause of the track circuit detection failure. A Shunt Tester was used to evaluate the track circuit parameters before and after removing the corrosion layer from the rail surface. The results showed that, before cleaning, the occupancy voltage remained at 11.95 V, and the track was not detected as occupied. After the rail surface was cleaned, the occupancy voltage decreased to 2.83 V, while the short-circuit current increased from 360 mA to 978 mA, exceeding the minimum operating requirement of 500 mA. These findings indicate that the track circuit equipment functioned properly and that the disturbance originated from the condition of the rail surface rather than equipment malfunction.

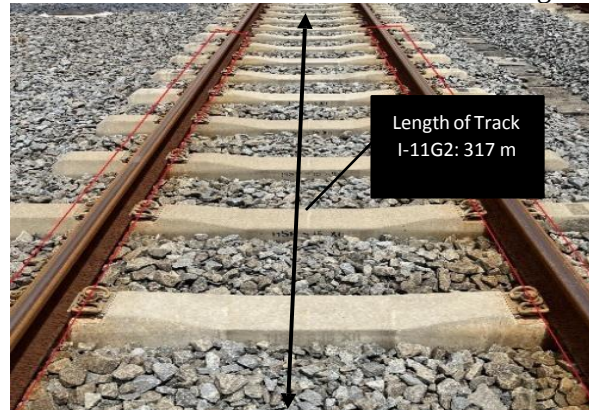
**Picture 3. Rail Head Corrosion on Track I-11G2**

A visual inspection of Track I-11G2 revealed the presence of surface corrosion characterized by a brown oxide layer on the rail head. The corrosion increased the electrical contact resistance between the wheel and rail, reducing the effectiveness of the *shunting* process. However, the observed corrosion was limited to the rail surface and had not affected the mechanical strength of the rail.

The formation of corrosion was also influenced by environmental conditions and track utilization. Rainfall data indicate that Bandung experiences relatively high humidity, accelerating the oxidation process on the rail surface. In addition, Track I-11G2 was operated on only 22 days during April 2026, limiting the natural removal of the oxide layer by wheel–rail contact. Consequently, corrosion accumulated more easily on the rail head than on frequently used mainline tracks.

The combination of high environmental humidity and low track utilization accelerated the formation of corrosion on the rail head. The resulting oxide layer increased the wheel–rail contact resistance, reducing the *shunting* current flowing through the *track circuit*. This condition led to *bad shunting*, in which the train physically occupied the track but could not be reliably detected by the *track circuit*. These findings are consistent with Xu et al. (2021), who reported that oxide layers on the rail surface increase wheel–rail contact resistance and reduce the reliability of *track circuit* systems. Similar findings were reported by Satria et al. (2023), who identified rail head corrosion as one of the primary causes of *bad shunting* in railway signaling systems. Therefore, it can be concluded that rail head corrosion was the dominant factor contributing to the *track circuit* detection failure that triggered the *Emergency Brake* activation on Track I-11G2 at KCIC Tegalluar Depot.

Based on the analysis results, the primary cause of the *Emergency Brake* activation was not a signaling equipment failure but rail head corrosion, which increased the wheel–rail contact resistance and resulted in *bad shunting*. Therefore, the proposed mitigation should reduce the system's dependence on *track circuit* detection in sections susceptible to corrosion. This study proposes an operating pattern in which the train remains in Full Supervision (FS) mode until Track I-11G1 and then switches to Shunting (SH) mode before entering Track I-11G2. In *Shunting* mode, train movement is no longer fully dependent on *track circuit* occupancy detection but primarily relies on balise information while maintaining the prescribed shunting speed limits.

As shown in Table 6, the proposed operating pattern reduces the dependence on the *track circuit* along Track I-11G2, thereby minimizing the risk of *Emergency Brake* activation caused by *bad shunting* while maintaining the safety functions of the Automatic Train Protection (ATP) system. Compared with periodic *rail grinding* or corrosion cleaning, which provide only temporary improvements, the proposed operating pattern addresses the root cause of the disturbance more effectively. The low utilization frequency of Track I-11G2, combined with the high rainfall and humidity in the study area, allows rail head corrosion to reoccur, making repeated maintenance necessary. In contrast, the proposed combination of Full Supervision (FS) and Shunting (SH) modes utilizes the existing CTCS-2 operational functions without requiring infrastructure modifications or signaling equipment replacement. Therefore, the proposed operating pattern offers a more effective, efficient, and sustainable solution for preventing *Emergency Brake* activation caused by *track circuit* detection failures.
